Five-Year Review Report
for
Northern Engraving Corporation

Sparta, Wisconsin

August, 2005

**Wisconsin DNR for
U.S. EPA Region 5**

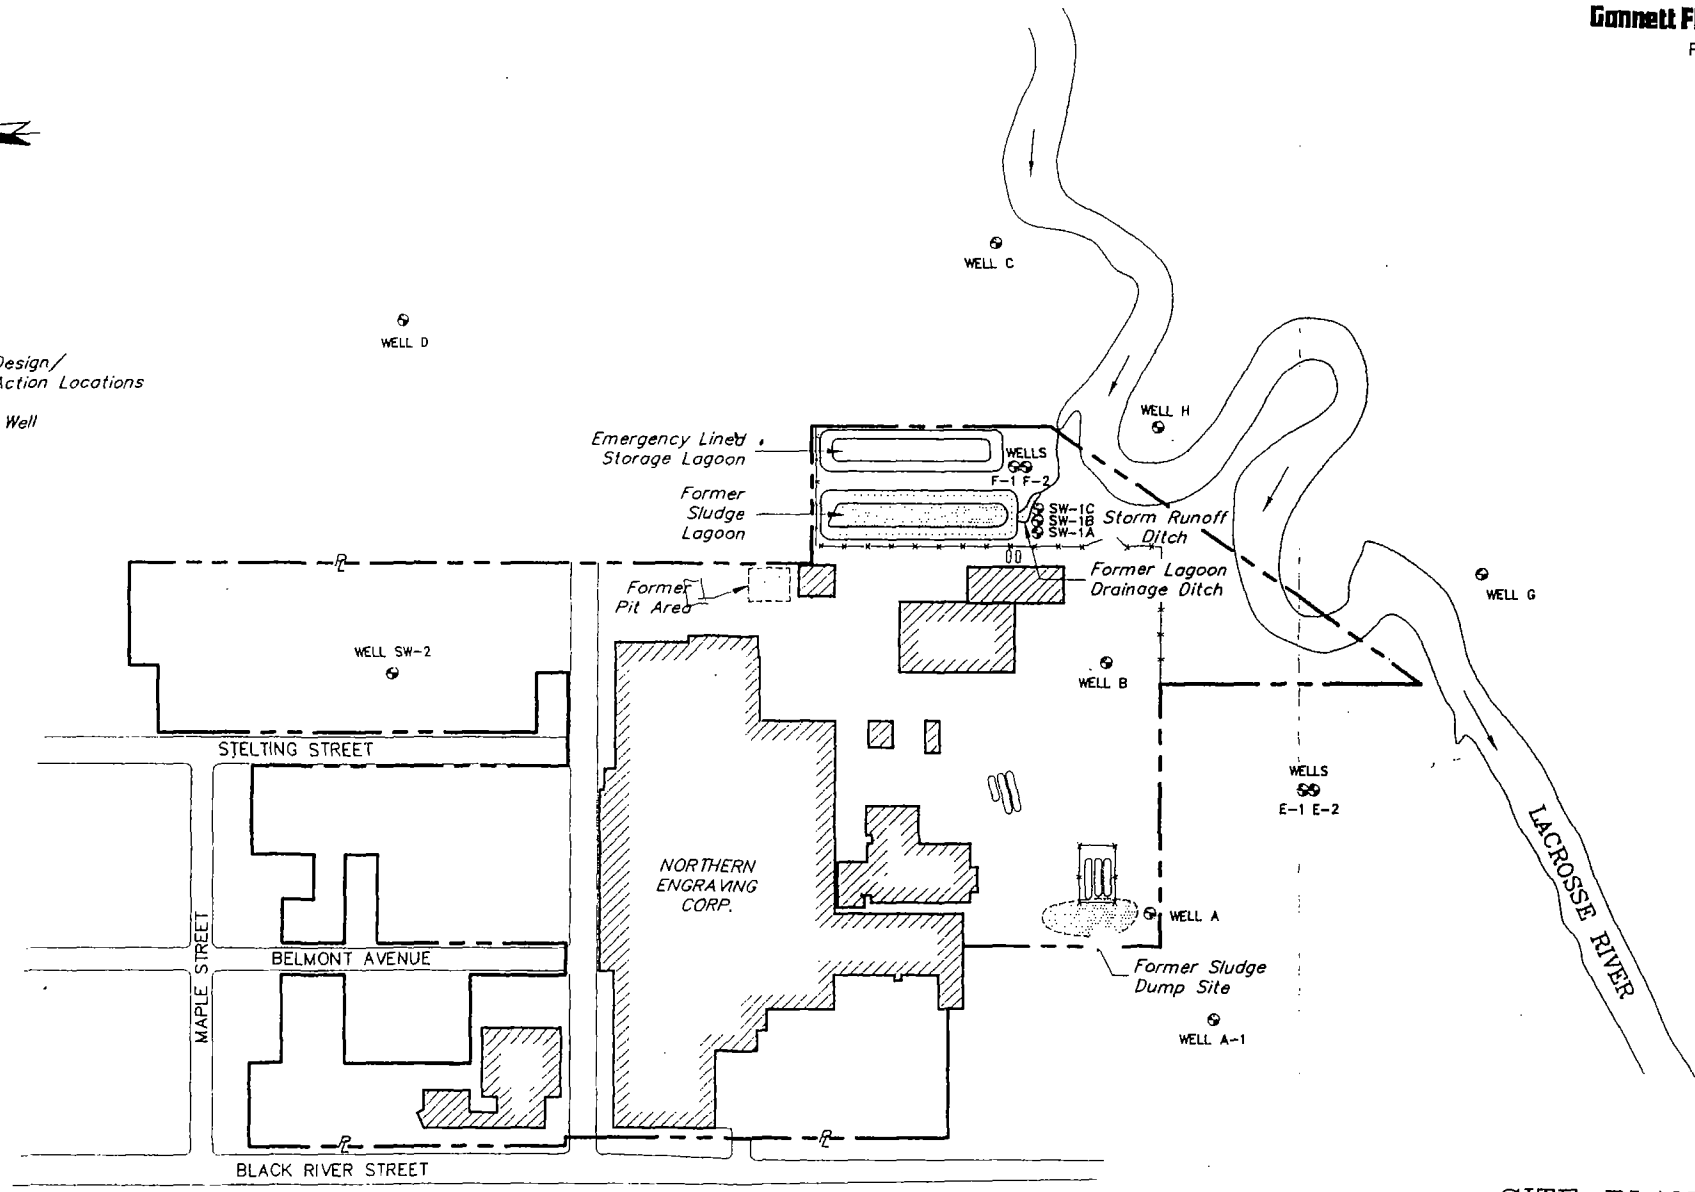
Fence

No significant issues have been identified at any time regarding the cap, the drainage structures, or the fence. Examination of the cap revealed that grass was in good condition. The cap and the surrounding area were undisturbed.

The inspection logs were examined (See Attachment 3). It was noted that the fence inspection was not listed as an inspection item and it is recommend that it be added to the log in the future.
